## PROPERTY INSPECTION REPORT

**Prepared For:** Example Report  
(Name of Client)

**Concerning:** 2222 Example Drive Richmond, TX  
(Address or Other Identification of Inspected Property)

**By:** Scott Hinsley TREC #7050 07/11/2011  
(Name and License Number of Inspector) (Date)

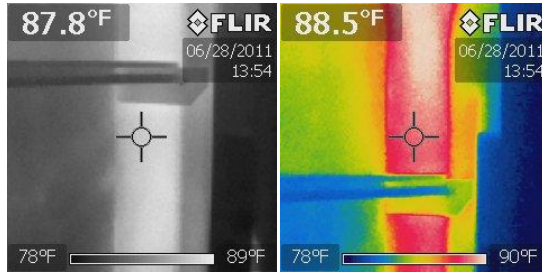
Observed missing or compressed insulation at upper left rear bedroom closet rear wall corner, further investigation is recommended and repairs should be undertaken if necessary.

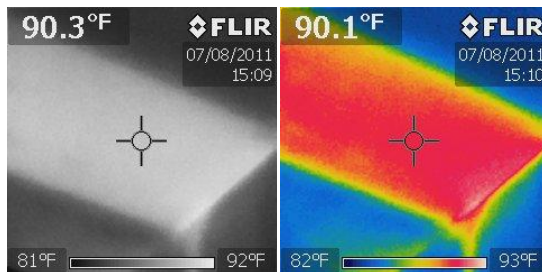
Observed missing or compressed insulation at upper right hallway outside guest bedrooms, further investigation is recommended and repairs should be undertaken if necessary.
